PEEKshrink® Sleeving Over Spliced Wire

PEEKshrink®

SPLICING RECOVERY GUIDE

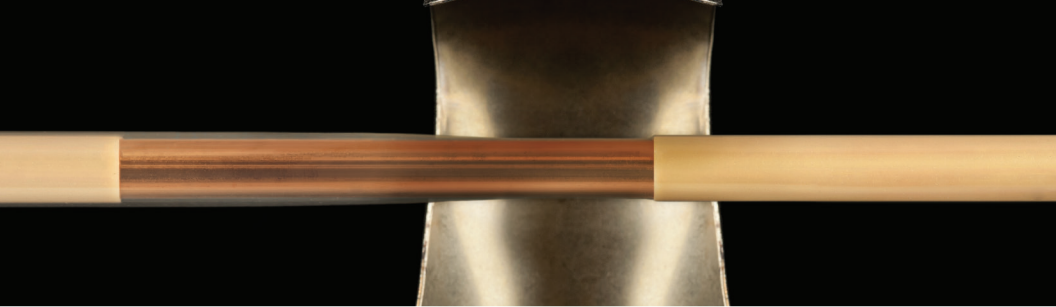
Several reducer and reflector accessories come standard with the HG 2310 LCD. The reflector baffle was used to achieve a surrounding air current in this application.

Setting the gun at 850°F/454°C creates an airflow current ranging in temperature from 640°F/338°C to 700°F/371°C in the location of the baffle reflector where the splice will be.

STEINEL ELECTRONIC HEAT GUN

MODEL HG 2310 LCD.

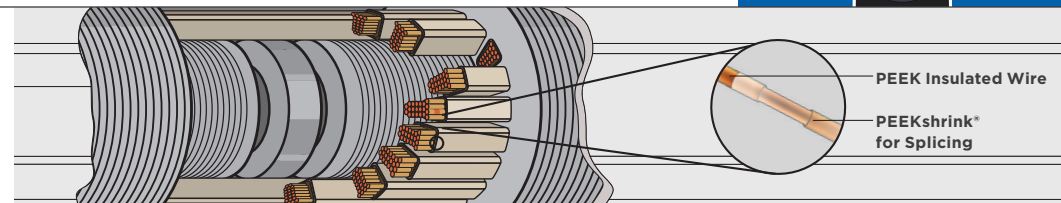
- 4 Anchor the PEEKshrink on one end and work from there toward the other end. Observe when shrinking occurs and move the heat to the other side to ensure a uniform recovery 360 degrees around the wire. Be aware of the bare coated wire. Too much heat or heat sink in the wire can melt the coating beyond the edges of the sleeve.
